# **CASTING BASIN GATE MAINTENTANCE RECORDS**

CYCLE 6

# Kiewit-General Inspection Report

**PROJECT:** SR 520 PONTOONS

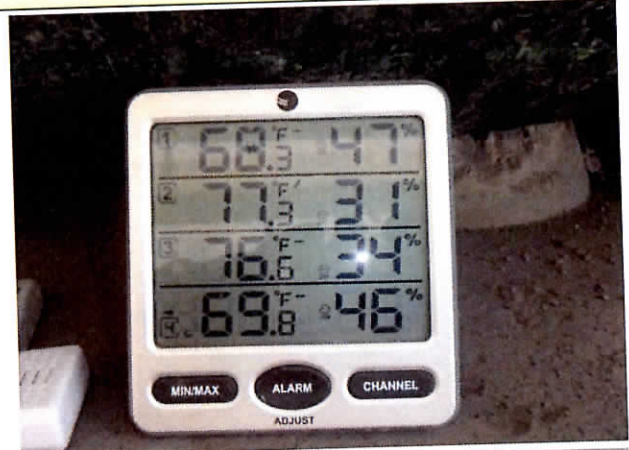
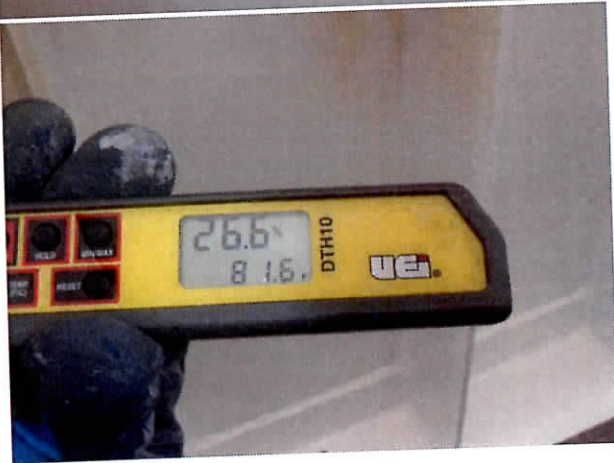
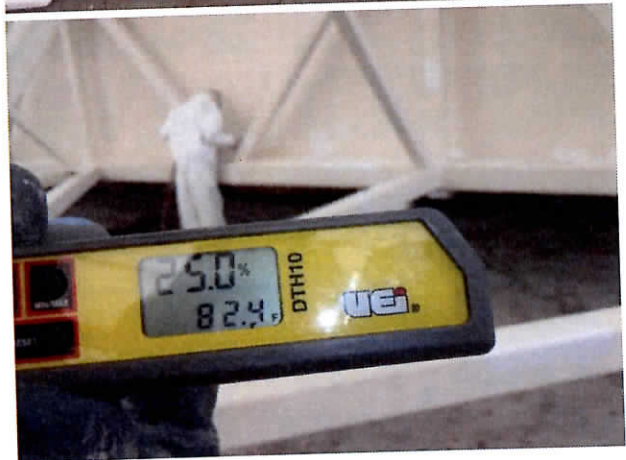
IDR Sheet Sheet 7 of 7	QA Key Personnel Function Structural Inspector	Date Tuesday, March 17, 2015
Inspector Doug Brinius		IDR Report # 3/17/2015 DB
Inspector's Notes Continued

TOP FOUR: Atmospheric conditions for T2 and T3 top coats, wet film thickness testing

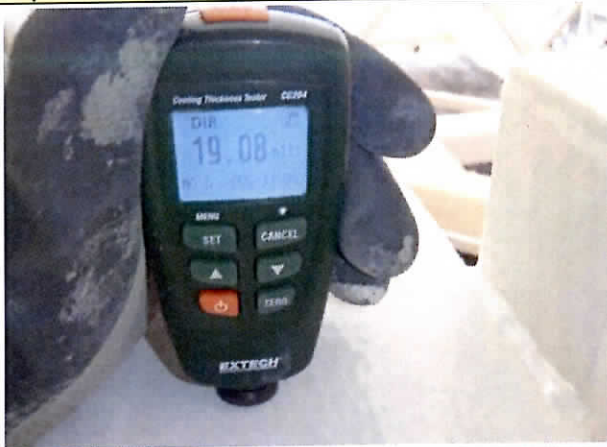
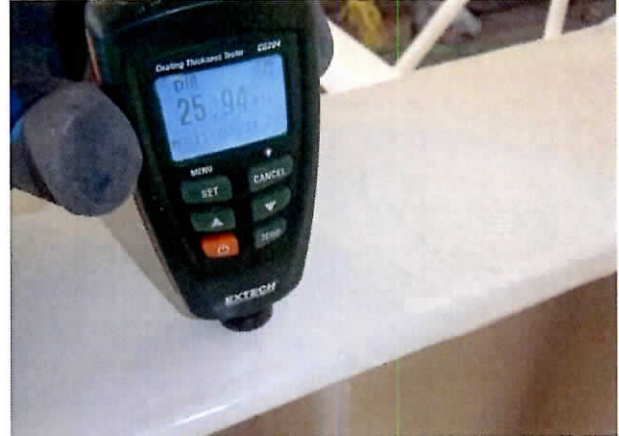
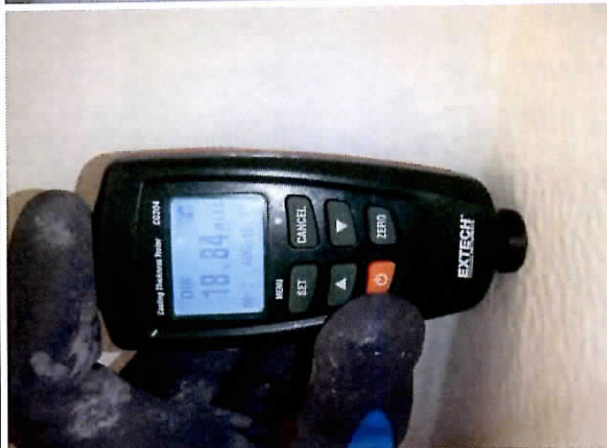
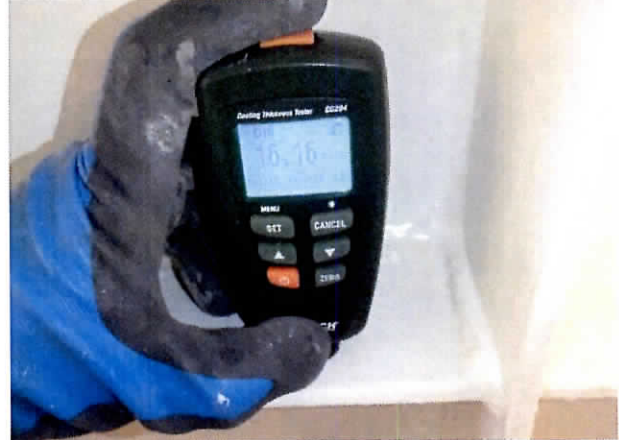
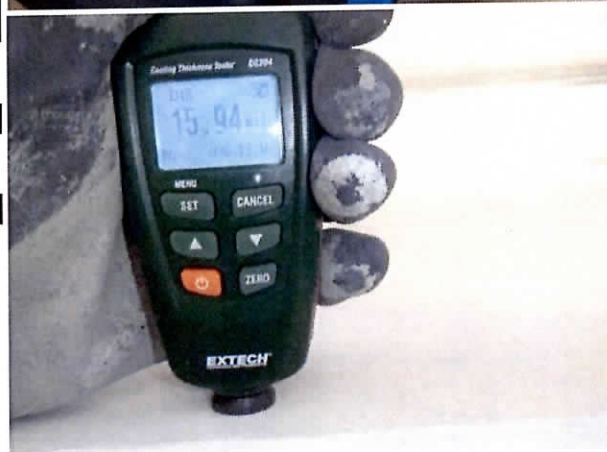
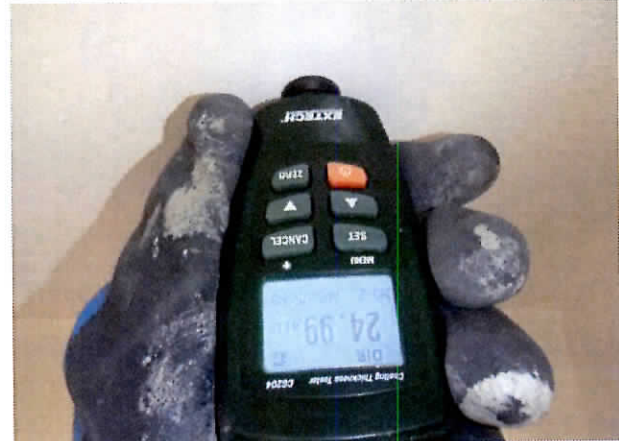
IDR Sheet	QA Key Personnel Function	Date
Sheet 4 of 11	Structural Inspector	Wednesday, March 18, 2015
Inspector	IDR Report #	
Doug Brinius	3/18/2015 DB	
Inspector's Notes

TOP SIX: Final DFT readings for Dura-Plate T2 and T3 top coats

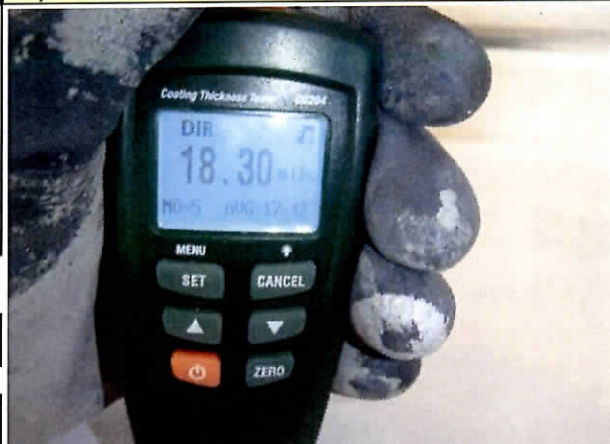
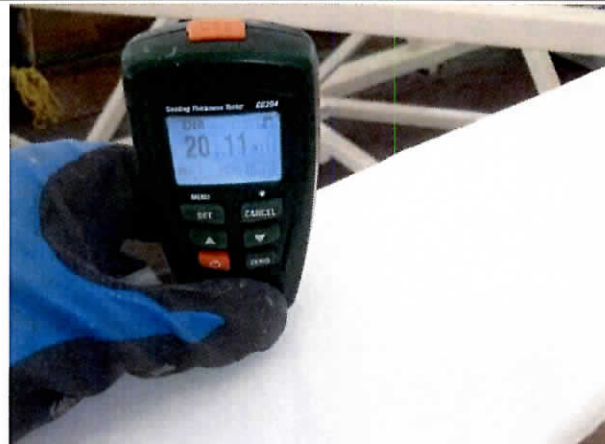
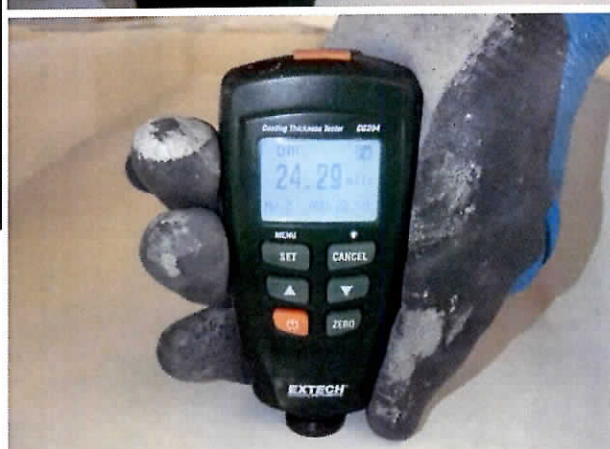
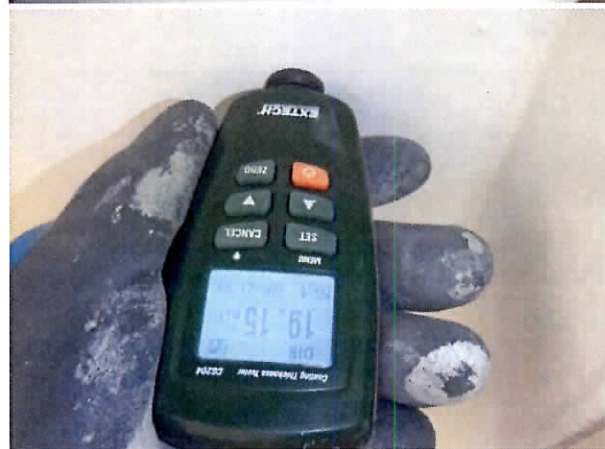
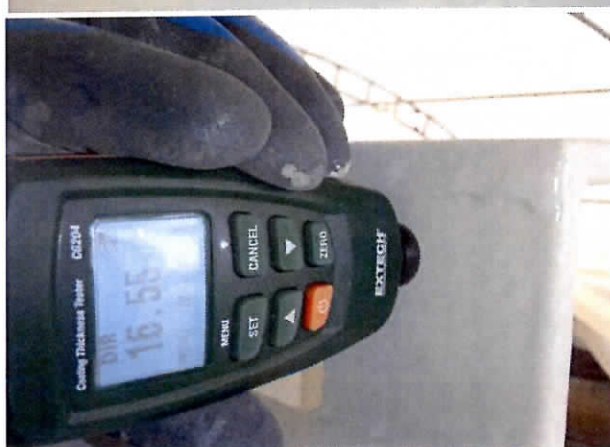
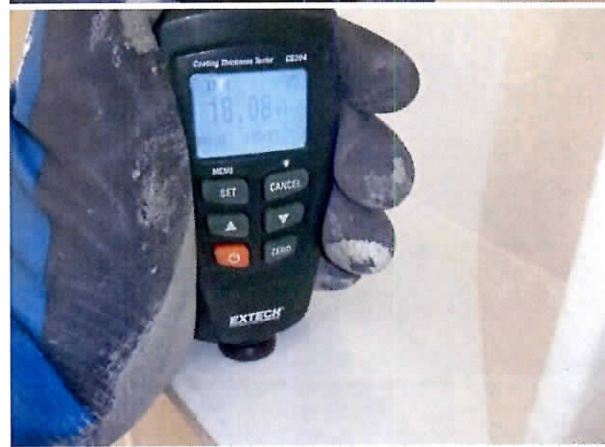
IDR Sheet	QA Key Personnel Function	Date
Sheet 5 of 11	Structural Inspector	Wednesday, March 18, 2015
Inspector	IDR Report #	
Doug Brinius	3/18/2015 DB	
Inspector's Notes Continued

TOP SIX: Final DFT readings for Dura-Plate T2 and T3 top coats

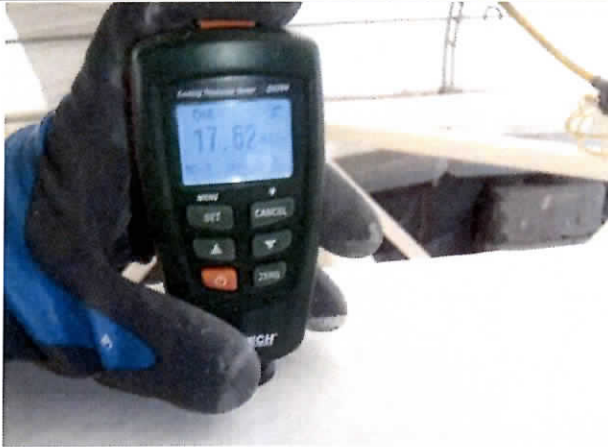
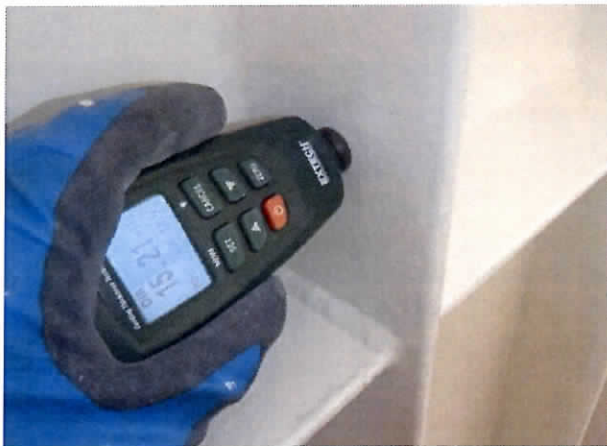
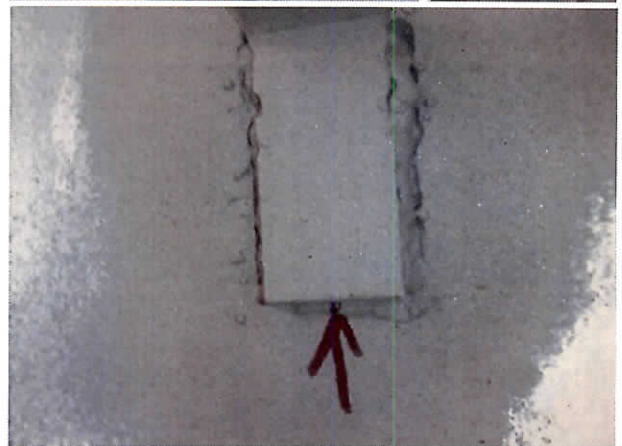
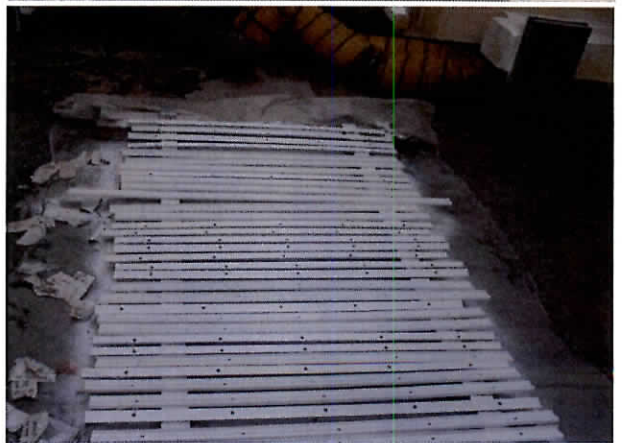
IDR Sheet	QA Key Personnel Function	Date
Sheet 6 of 11	Structural Inspector	Wednesday, March 18, 2015
Inspector Doug Brinius	IDR Report # 3/18/2015 DB	
Inspector's Notes Continued

TOP SIX: Final DFT readings, trusses 2 and 3, anchor profile, undercut in weld for zinc anode foot at 4T, SS clips primed

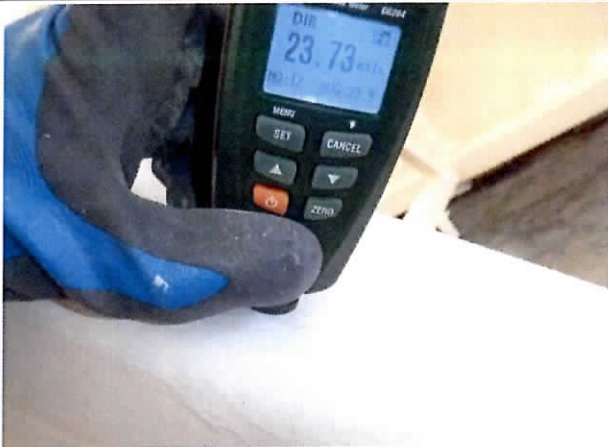
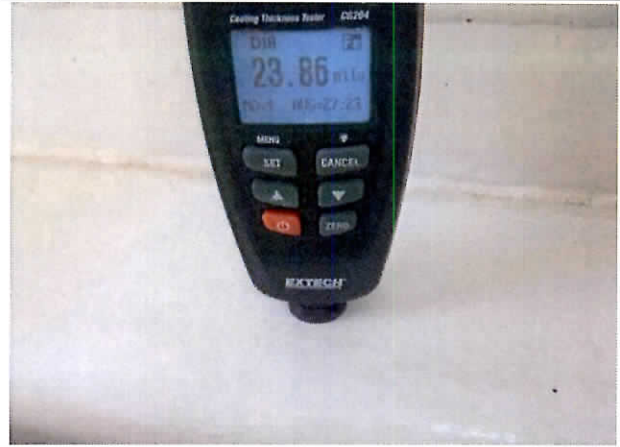
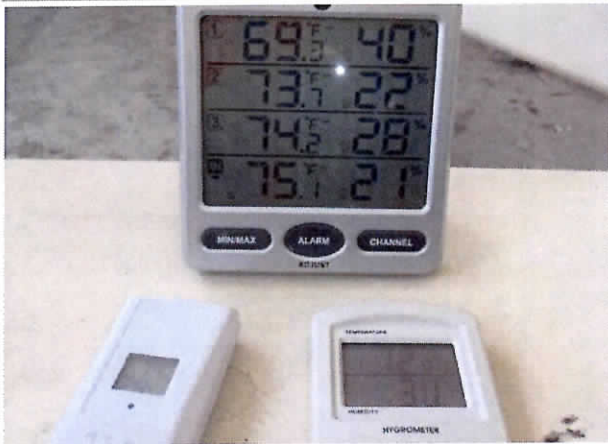
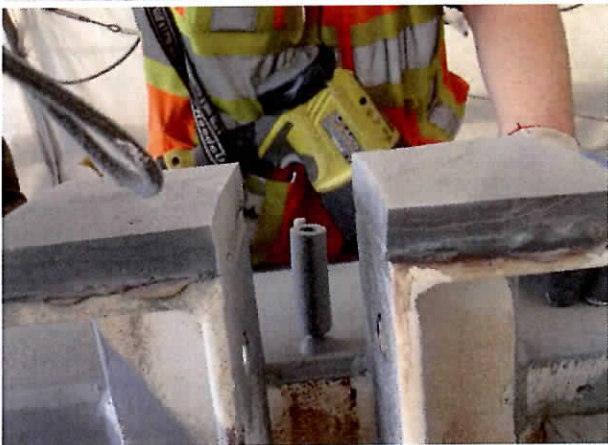
IDR Sheet Sheet 7 of 11	QA Key Personnel Function Structural Inspector	Date Wednesday, March 18, 2015
Inspector Doug Brinius	IDR Report # 3/18/2015 DB	
Inspector's Notes Continued

TOP TWO: Final DFT readings, trusses 2 and 3  
BOTTOM FOUR: Inspection of Zinc primer upon T1, WFT of zinc primer, atmospheric conditions and

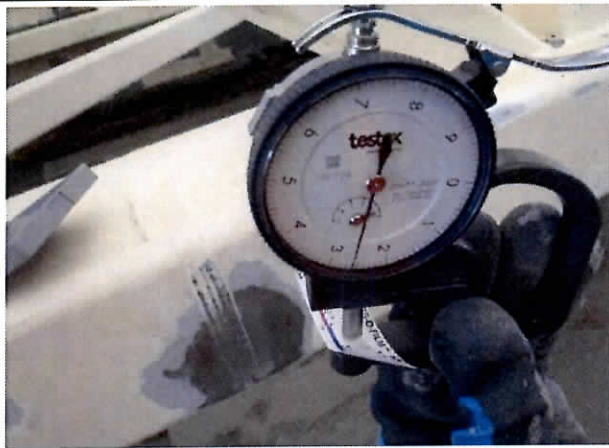
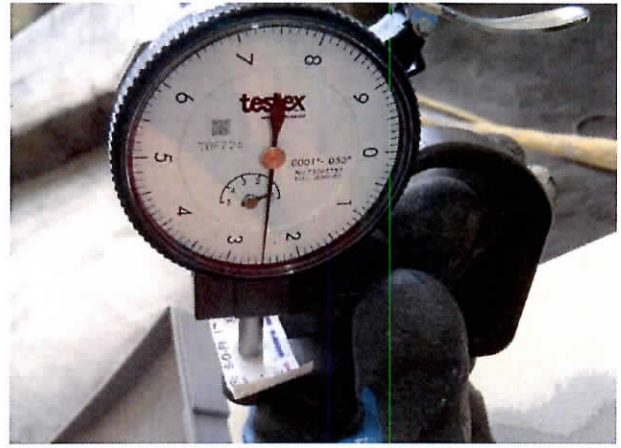
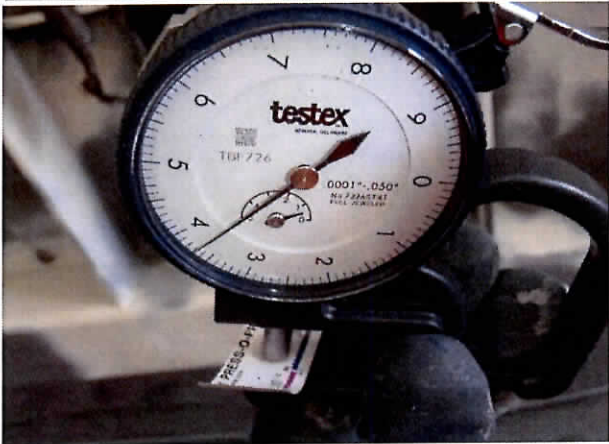
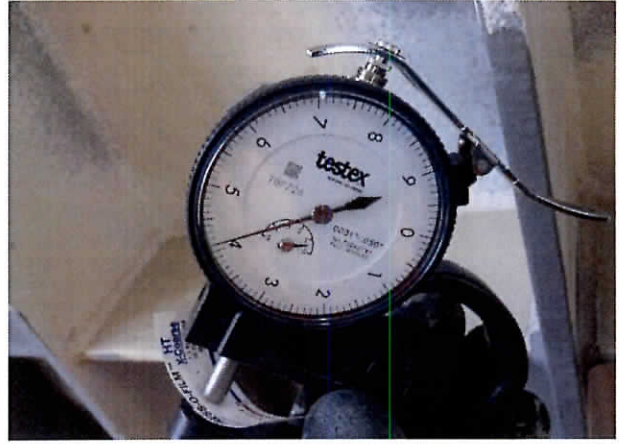
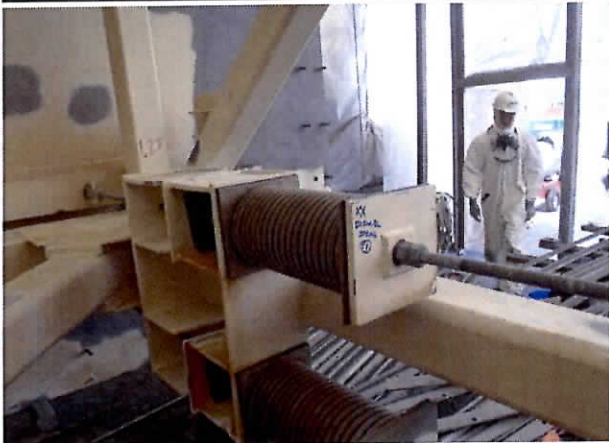
IDR Sheet	QA Key Personnel Function	Date
Sheet 8 of 11	Structural Inspector	Wednesday, March 18, 2015
Inspector	IDR Report #	
Doug Brinius	3/18/2015 DB	
Inspector's Notes Continued

TOP SIX: Anchor profile readings, Belleville springs to be disassembled, hole within anode weld, truss 1

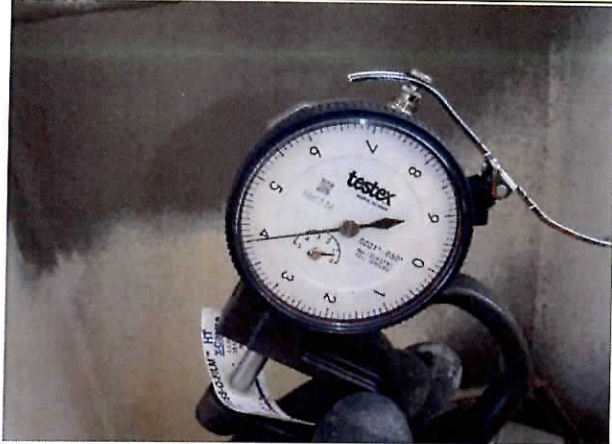
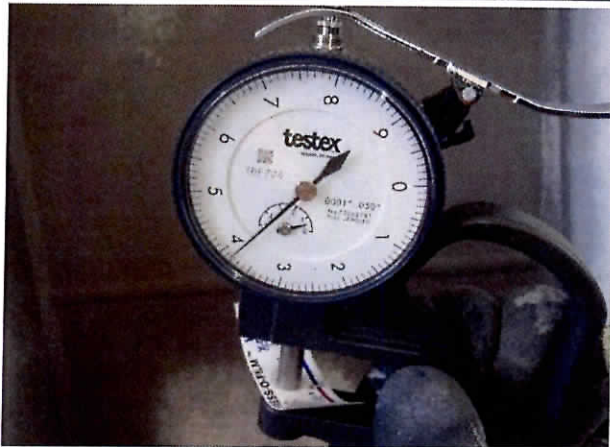
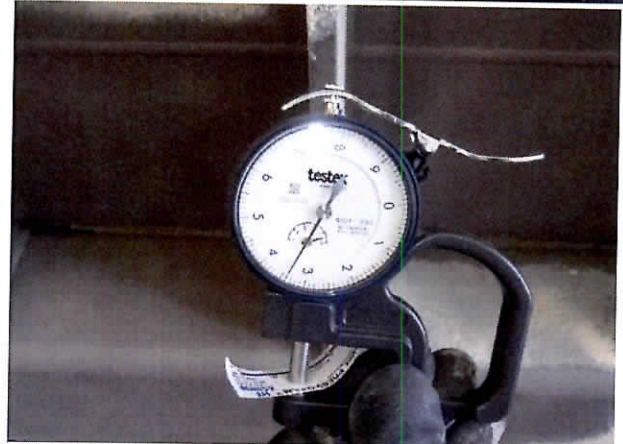
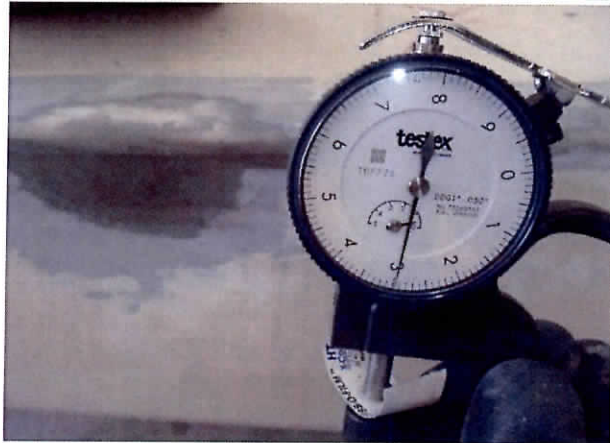
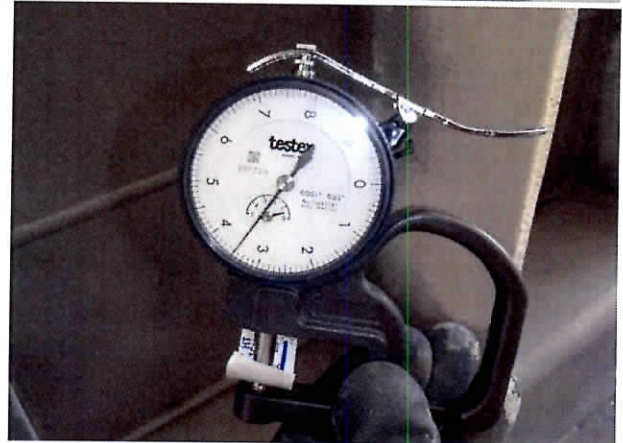
IDR Sheet	QA Key Personnel Function	Date
Sheet 9 of 11	Structural Inspector	Wednesday, March 18, 2015
Inspector Doug Brinius	IDR Report # 3/18/2015 DB	
Inspector's Notes Continued

TOP SIX: Anchor profile readings, truss 1

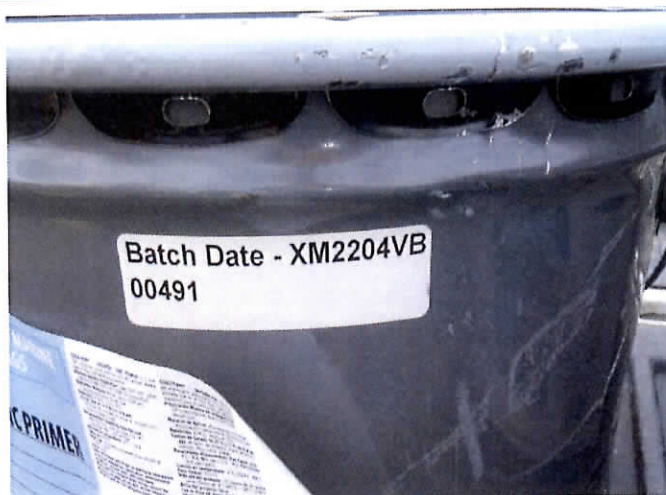
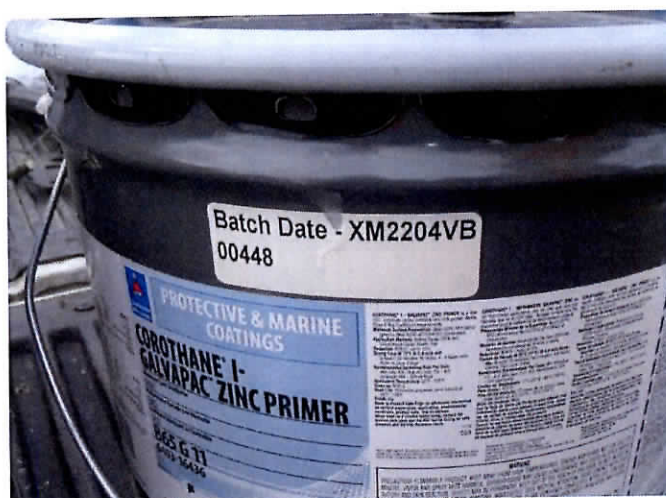
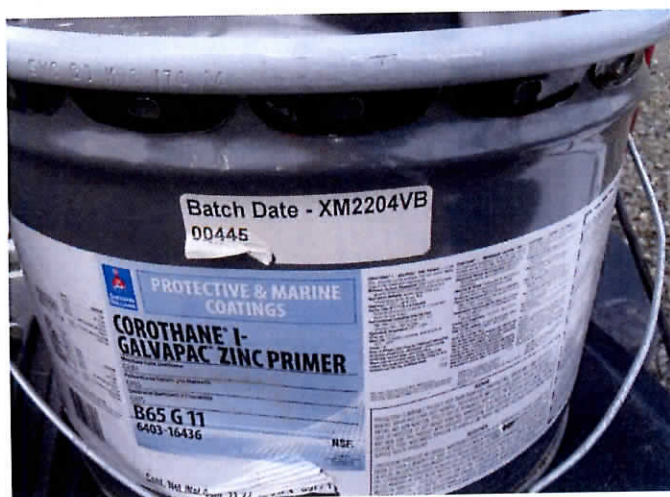
IDR Sheet	QA Key Personnel Function	Date
Sheet 10 of 11	Structural Inspector	Wednesday, March 18, 2015
Inspector	IDR Report #	
Doug Brinius	3/18/2015 DB	
Inspector's Notes Continued

TOP THREE: Zinc primers used for truss 1

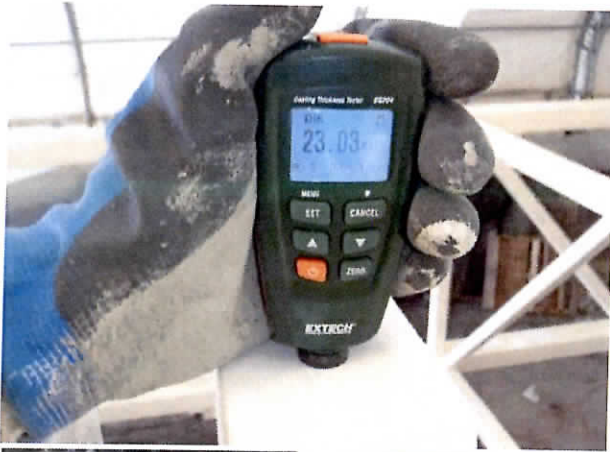
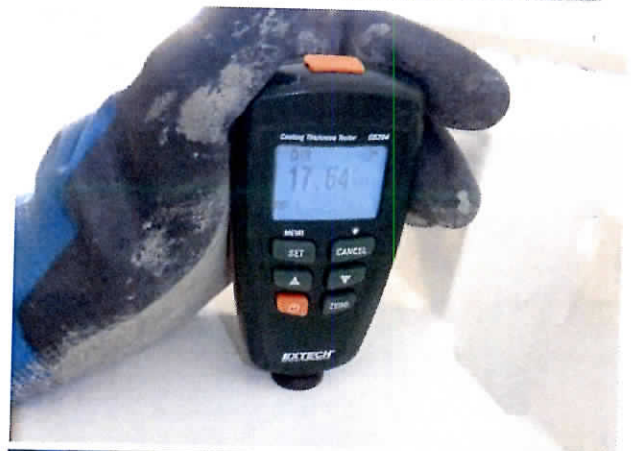
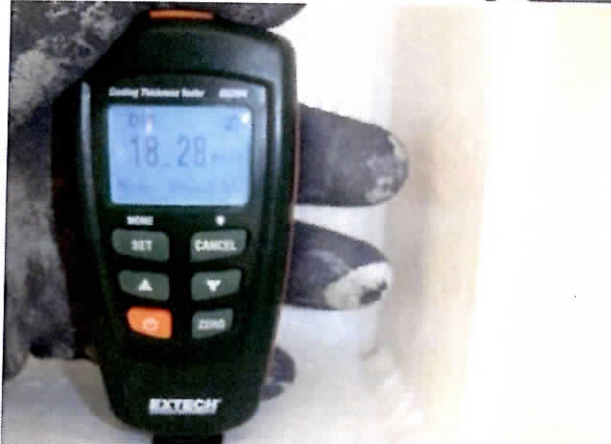
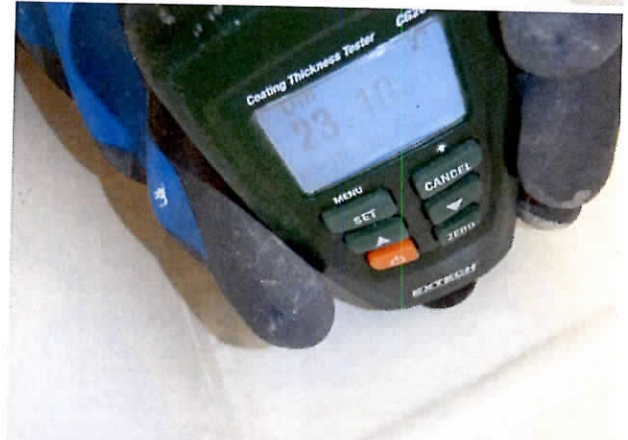
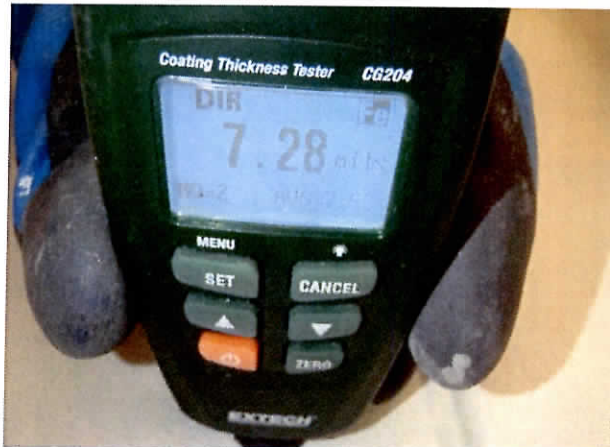
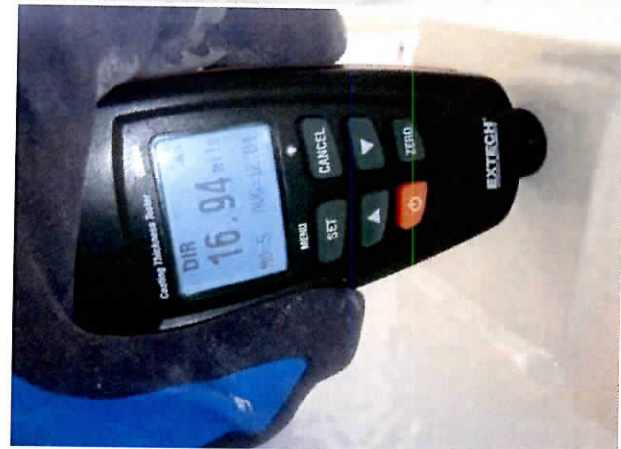
TOP SIX: Final DFT readings for Dura-Plate T2 and T3 top coats

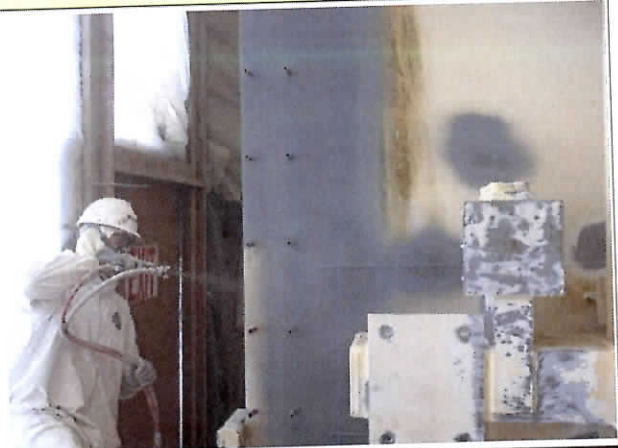
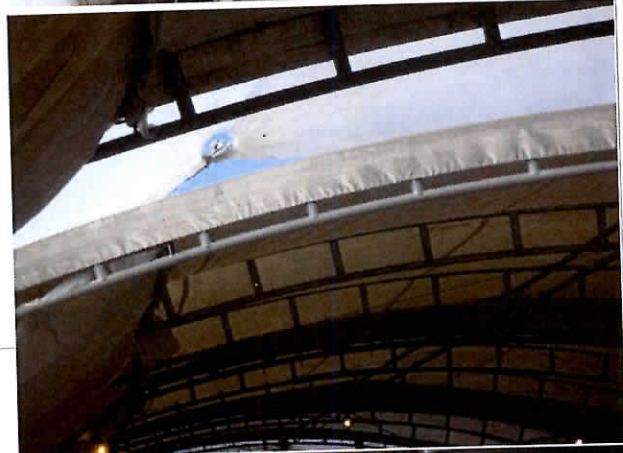
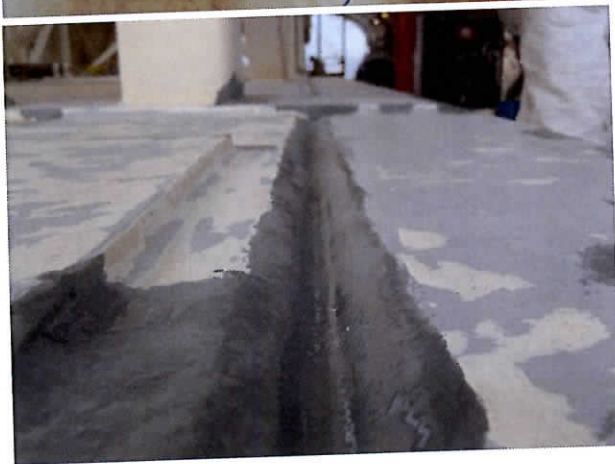
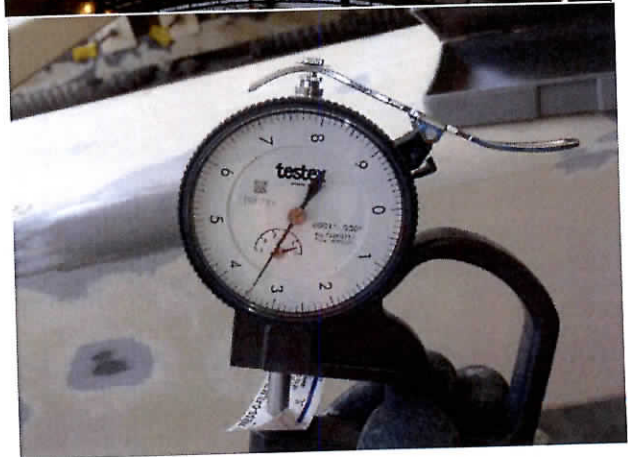
IDR Sheet	QA Key Personnel Function	Date
Sheet 3 of 18	Structural Inspector	Thursday, March 19, 2015
Inspector Doug Brinius	IDR Report # 3/19/2015 DB	
Inspector's Notes

TOP SIX: Atmospheric conditions and anchor profile testing for application of Zinc primer to T1, primer application

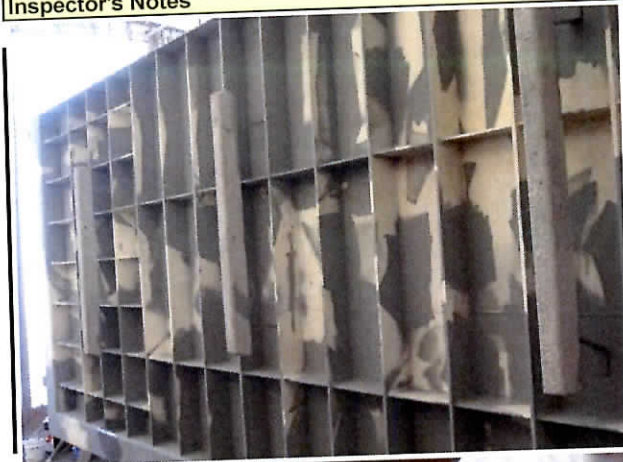
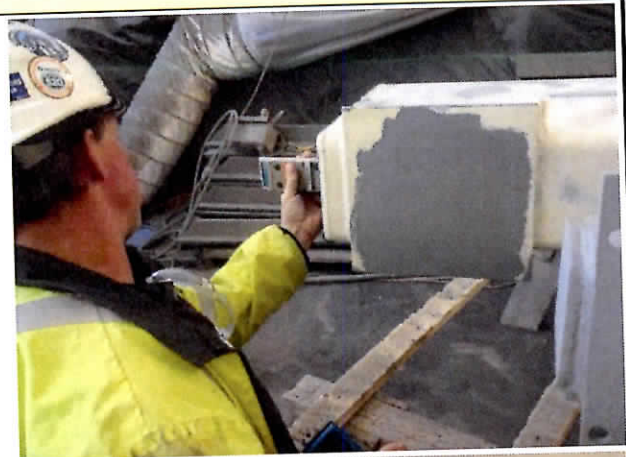
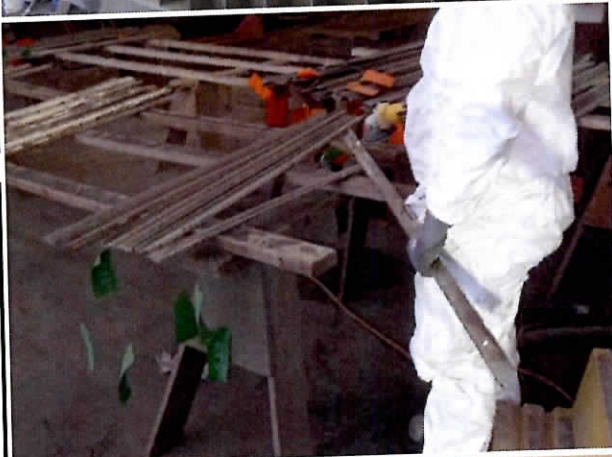
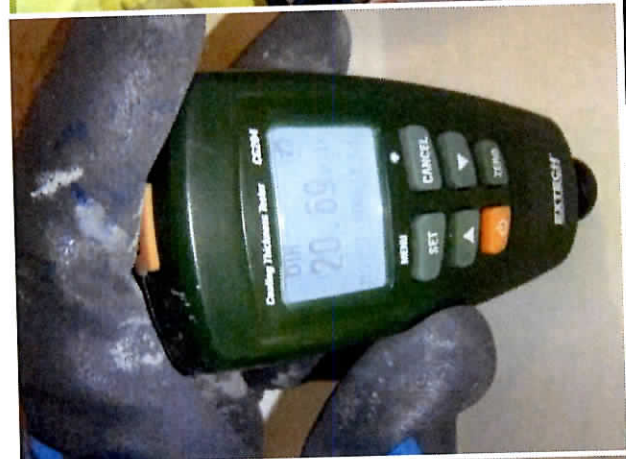
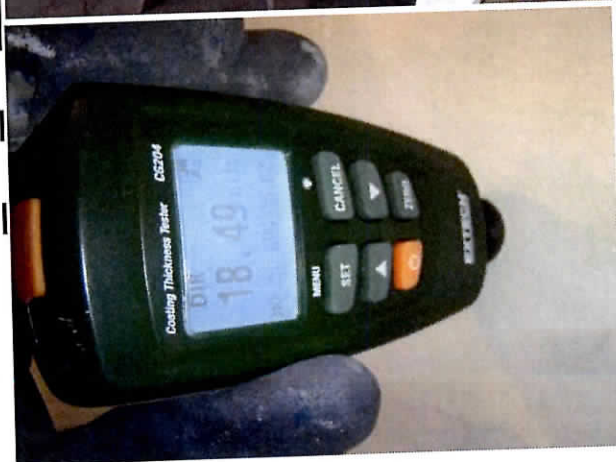
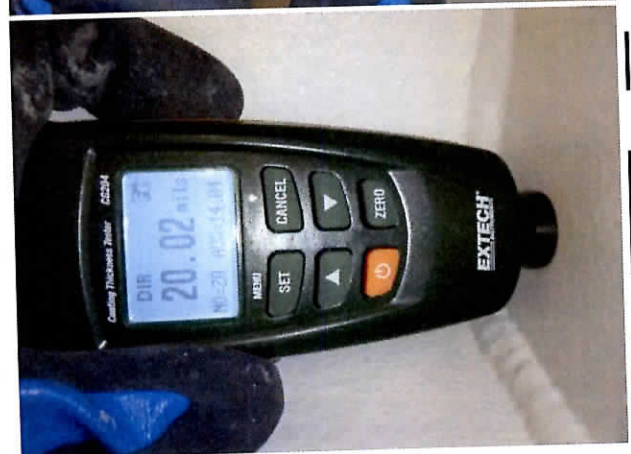
IDR Sheet	QA Key Personnel Function	Date
Sheet 4 of 18	Structural Inspector	Thursday, March 19, 2015
Inspector	IDR Report #	
Doug Brinius	3/19/2015 DB	
Inspector's Notes

TOP SIX: Final DFT readings for Dura-Plate T2 and T3 top coats, grinding SS clips of old coatings, zinc primer on T1 and independent QV DFT verification.

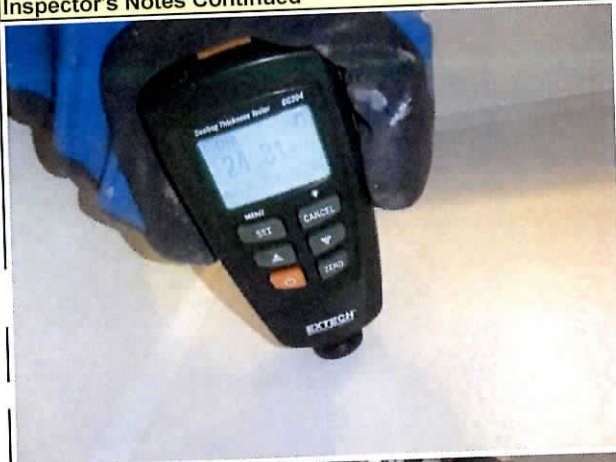
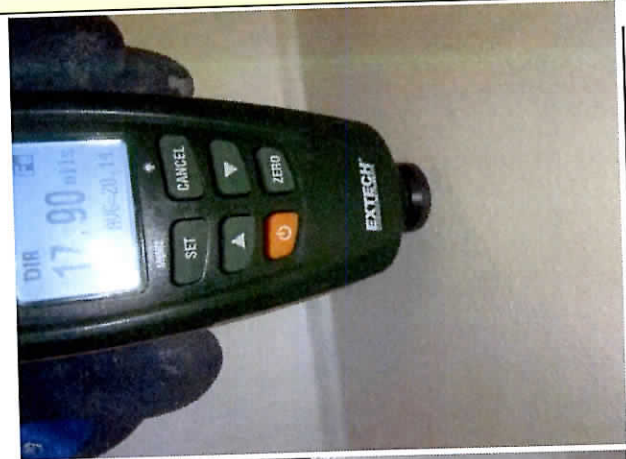
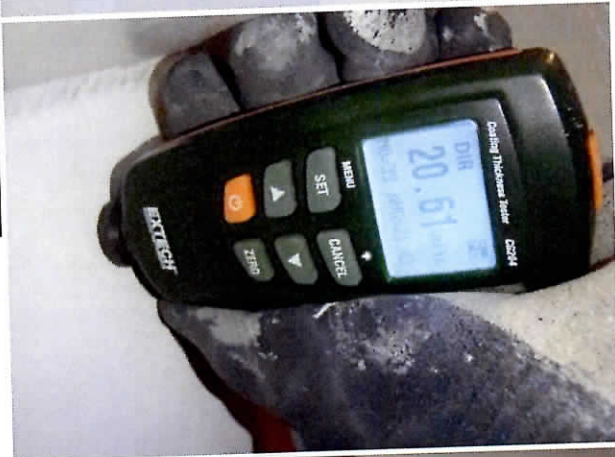
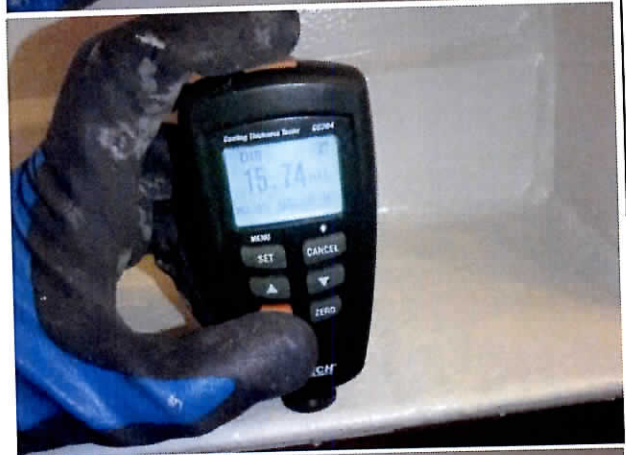
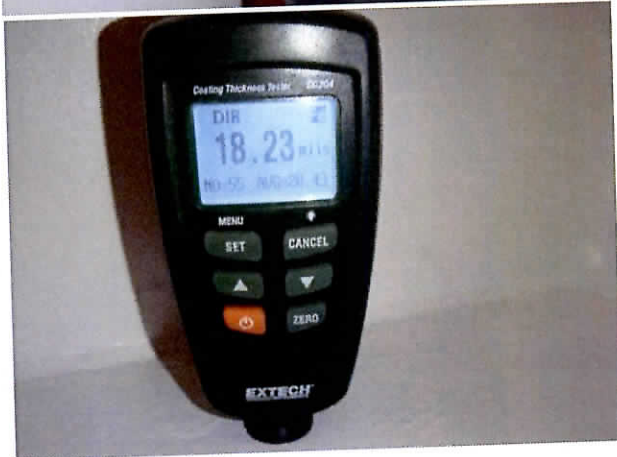
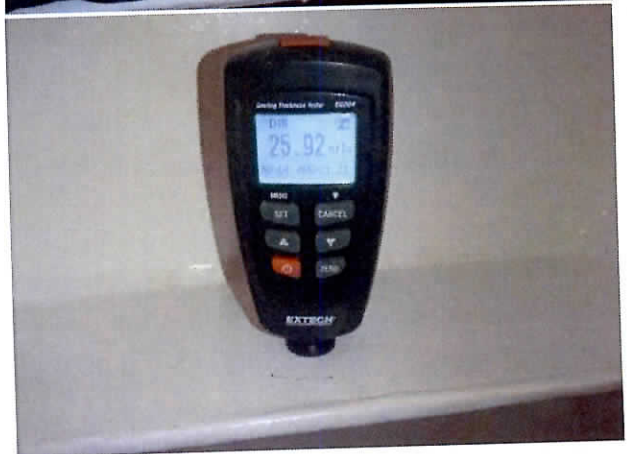
TOP SIX: Final DFT readings, trusses 2 and 3

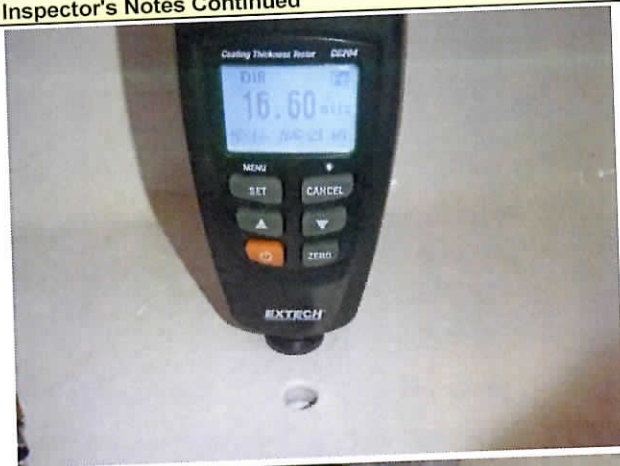
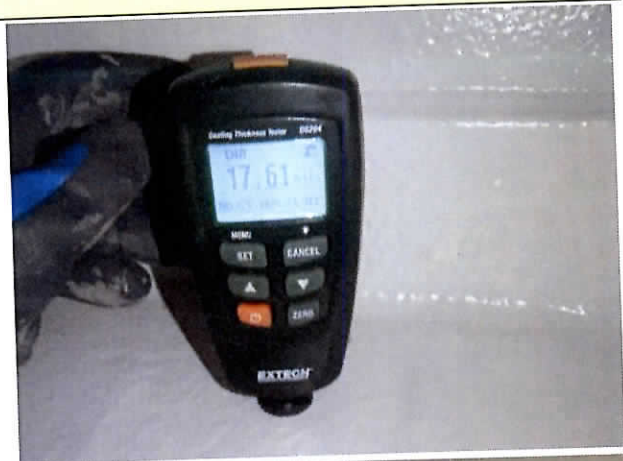
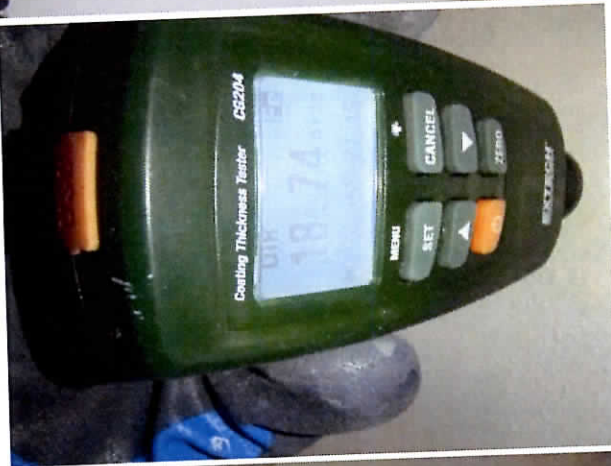
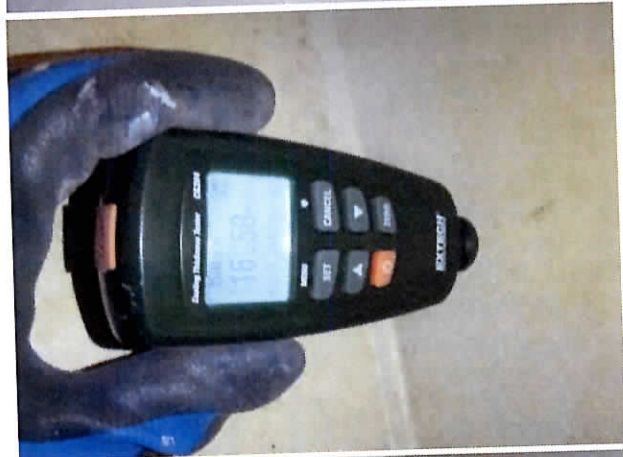
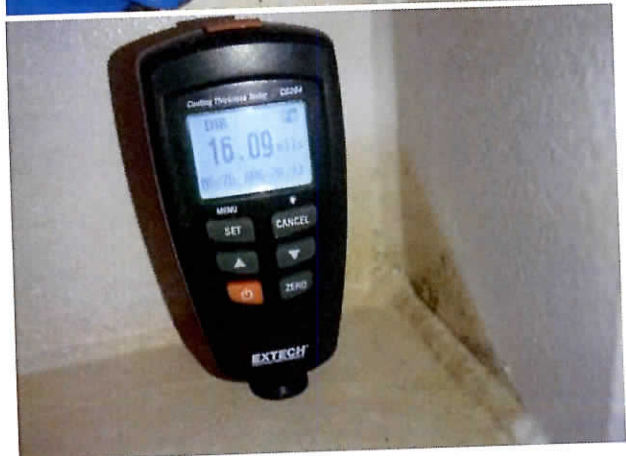
TOP SIX: Final DFT readings, trusses 2 and 3

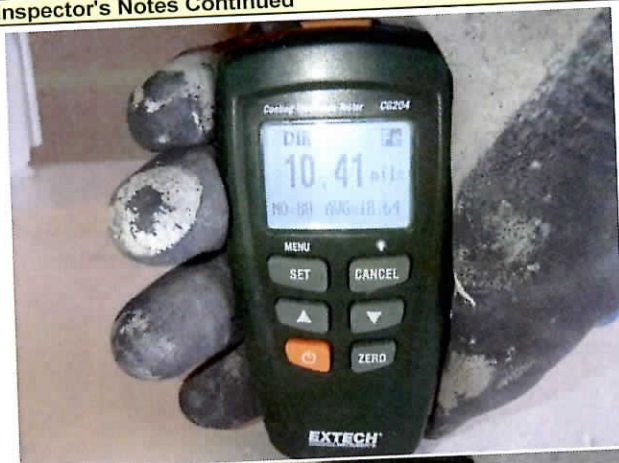
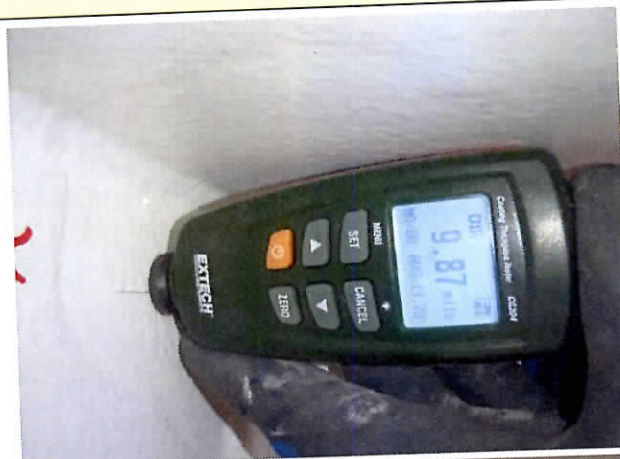
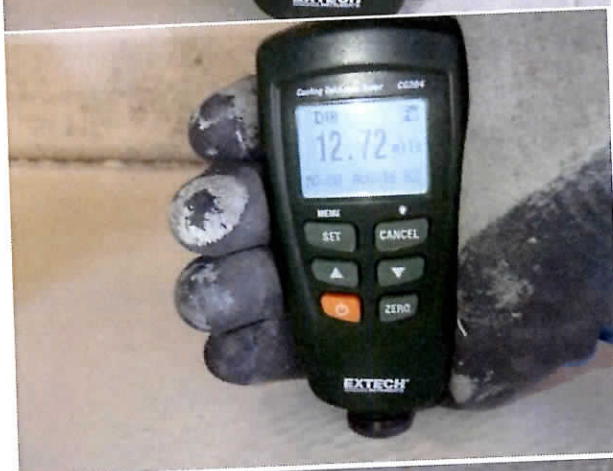
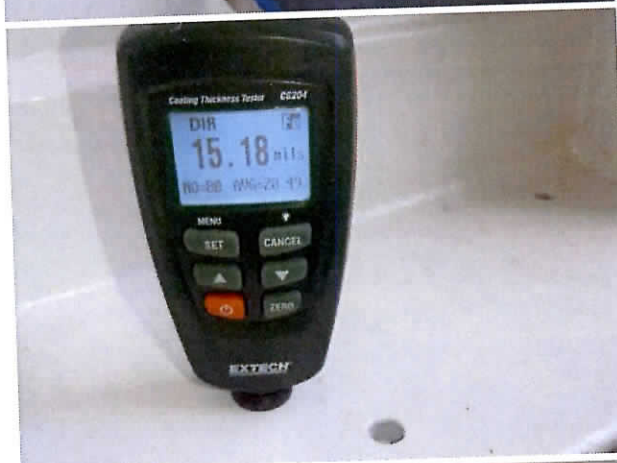
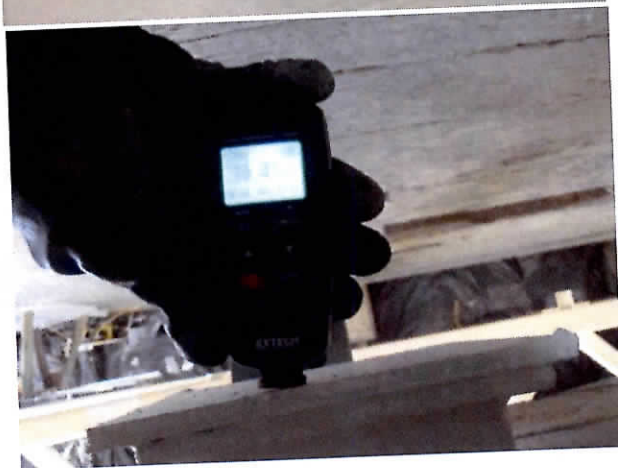
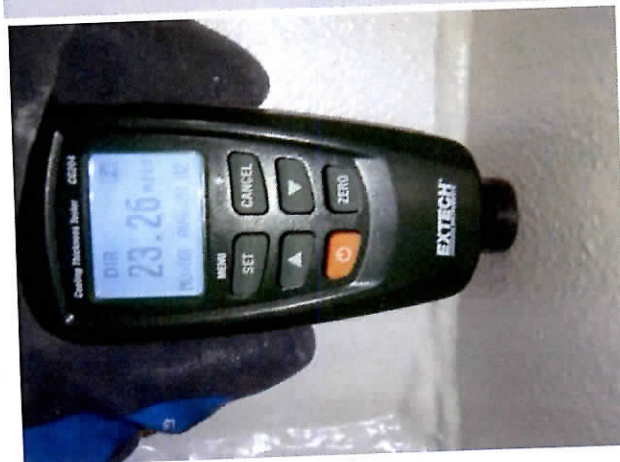
TOP SIX: Final DFT readings, trusses 2 and 3, with noted areas requiring second coat (top two)

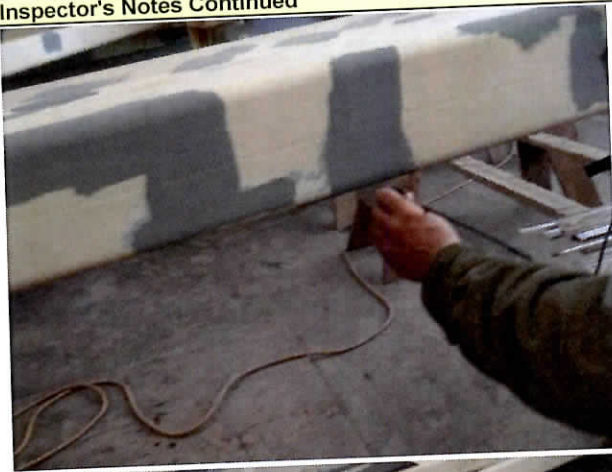
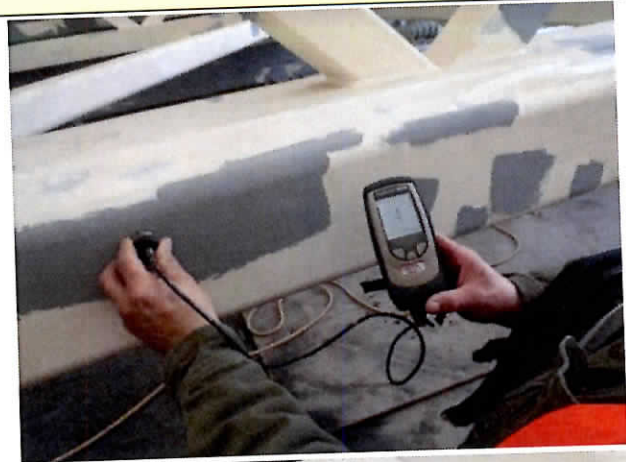
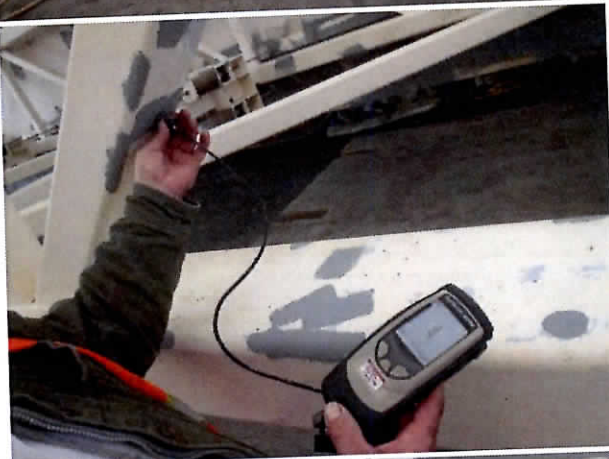
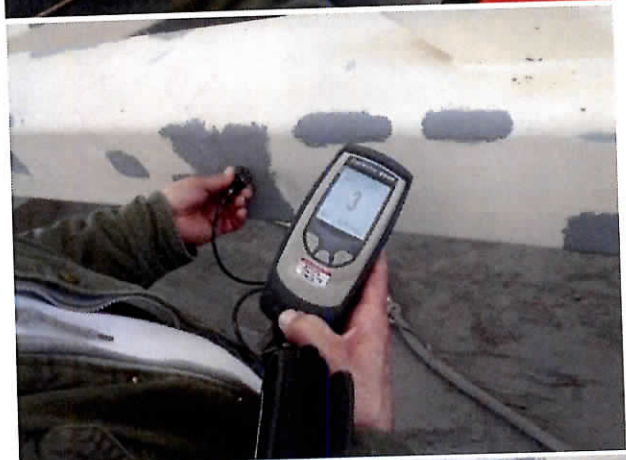
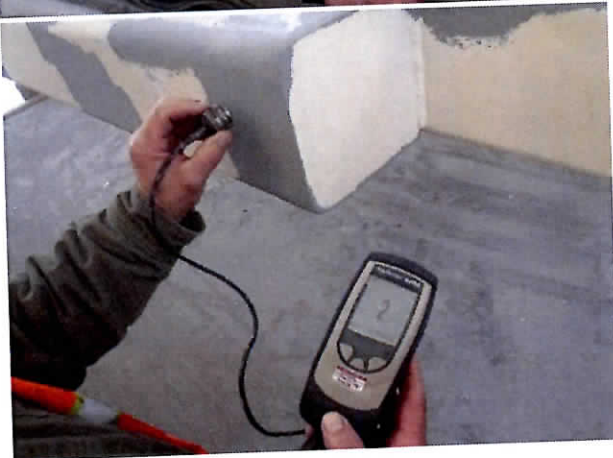
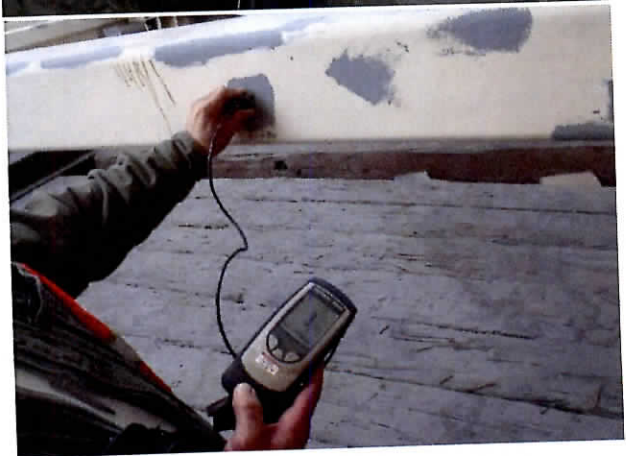
TOP SIX: DFT readings for Zinc primer of T1

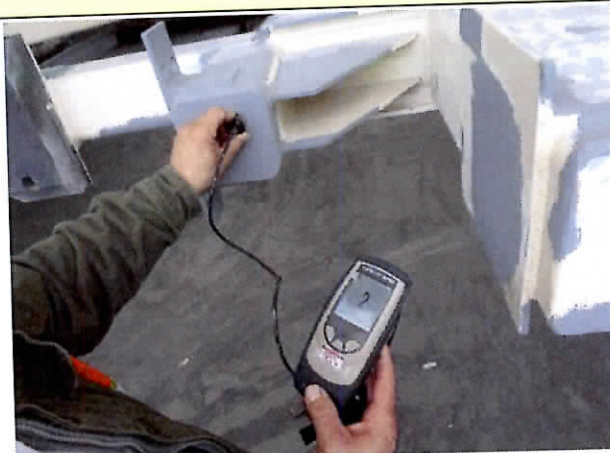
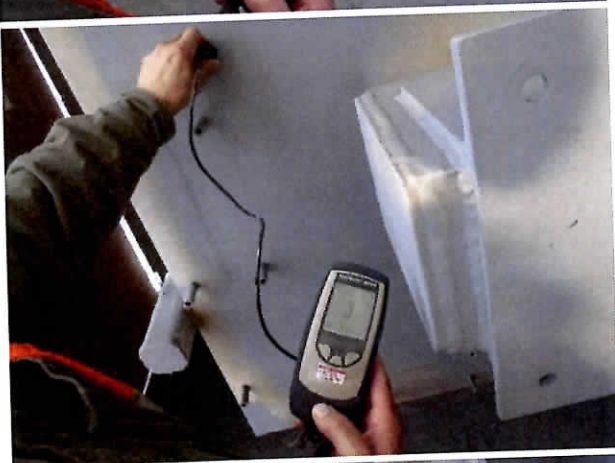
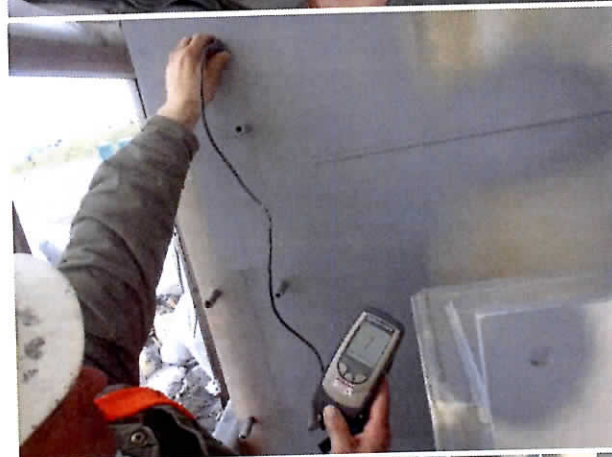
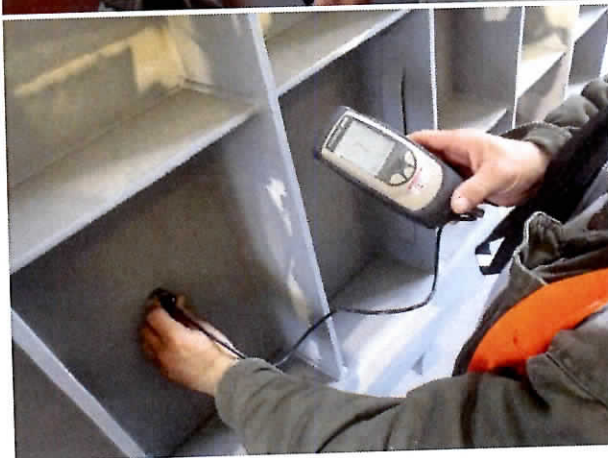
TOP SIX: DFT readings for Zinc primer of T1
